The Use of Steel Wool or a Wire Brush

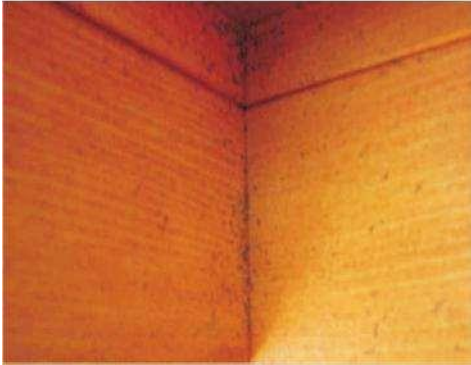
The customer who took this picture thought that the dark spots in the corners were due to mold; however, they appeared within days after the finish was applied. We were able to obtain a small section of the discolored wood and looking at it gives the impression that the discolorations could have been mold or pieces of dirt present at the time of staining. Even under the microscope at 10X magnification, there was no indication of what caused the black spots.

Most of the directions for our finishes contain the statement, *“Do not use LIFELINE™ on surfaces that have been brushed or rubbed with steel wool or a wire brush. If you do, rust spots may appear under the finish.”* Fortunately, we rarely see the consequences of applying one of our finishes on a wall that has been subjected to steel wool or a wire brush, but occasionally it does happen.
