## Mill Glaze

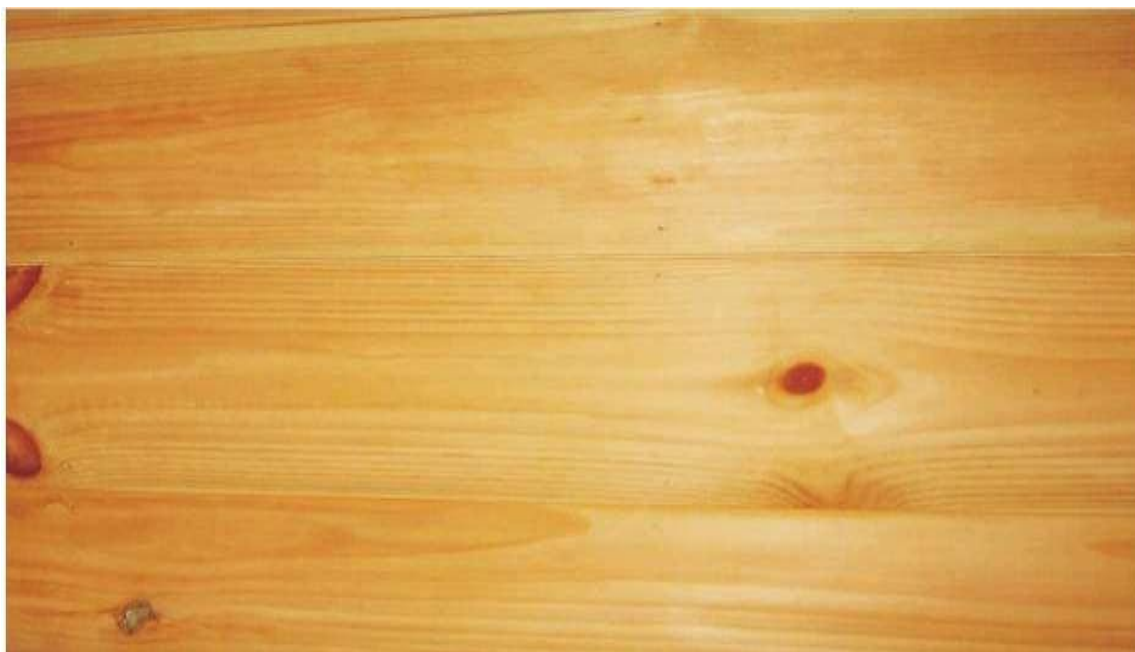
**Mill Glaze**

According to scientist working at Forest Products Laboratories alterations are concentrated in areas of flat grain lumber where there are abrupt early-wood (EW) late-wood (LW) transitions. The dense LW bands are crushed into less dense EW bands that lie directly beneath them. When these boards are later exposed to water, crushed EW absorbs water and rebounds which causes the surface LW bands to stick up from the surface. If not removed, this can interfere with the adhesion of both water and oil-based coatings since the wood's undamaged cellular surface is not in direct contact with the coating.
